57' Inner Flange Dislodged from Rim & Fell on Tyre Service Person

Safety Alert 90 130306 Inner Flange Dislodged From Rim and Strikes TSP

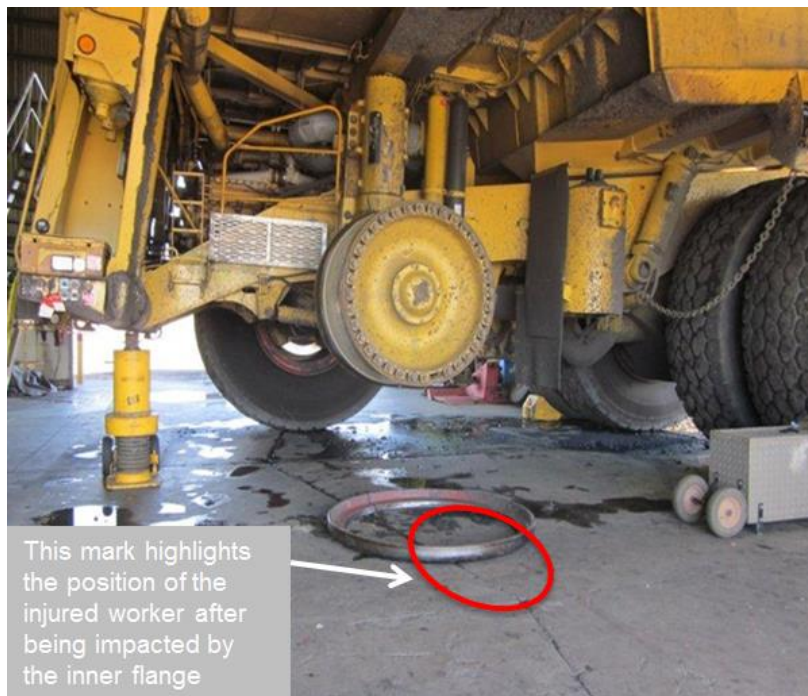
Whilst undertaking general cleaning of a rim on position 1 on a Komatsu 830E, during a vertical mount tyre change, the inner flange, which was still on the rim at the time, has dislodged, struck a tyre service person and pinned him to the ground across his pelvic region, causing multiple fractures.

Investigations into how the incident occurred, confirmed that whilst undertaking the cleaning of the rim, the tyre service person has moved the inner flange and or spun the rim, allowing the inner flange to walk towards the front of the rim.

Upon noticing the position of the inner flange on the rim (front section of the rim), the tyre service person has moved to the front of the rim and tried to push the inner flange on the left hand side around the 8 o'clock position. The tyre service person has then noticed that the right hand side of the inner flange was dislodging and he has taken a step to the right to try and push this side back however it was too late and the inner flange has struck the tyre service person and pinned him to the ground.

1. During all vertical mounts (TSR and Topy Rims) the inner flange shall be removed utilising a safe removal process (tyre handler preferably) and set aside in a safe position (on a suitable stand) for inspection and cleaning.
2. Ensure during all vertical mounts that the inner flange is in a SAFE position on the rim after the tyre and front componentry has been removed. (*Refer to photo below of SAFE position*).
3. If the inner flange does move on the rim to an 'unsafe' position (after removal of the wheel assembly), use the tyre handler OR have 2 Tyre Service Persons push the inner flange back to the identified SAFE position.
4. NEVER spin the rim whilst the inner flange is on the rim.
5. NEVER put oneself in the 'line of fire' or 'crush zone' of falling componentry.

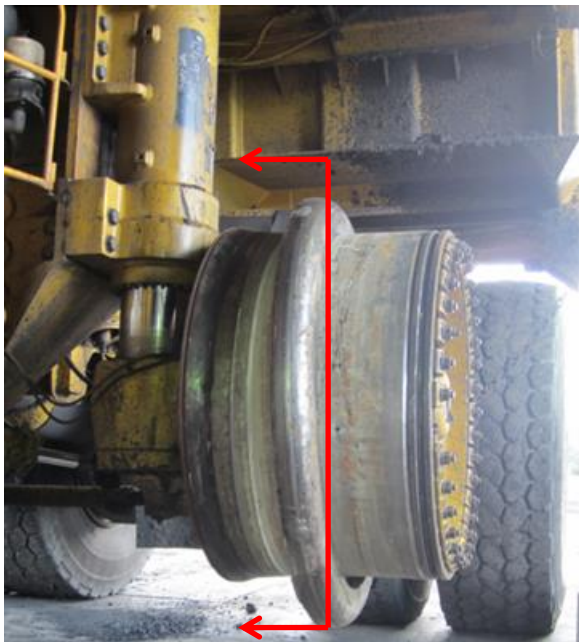
Recommendation 1

The SAFE position for the inner flange whilst on the rim would be no further forward than the position identified in this photo.

If the inner flange moves to the front half of the rim then put recommendation 2 into place.

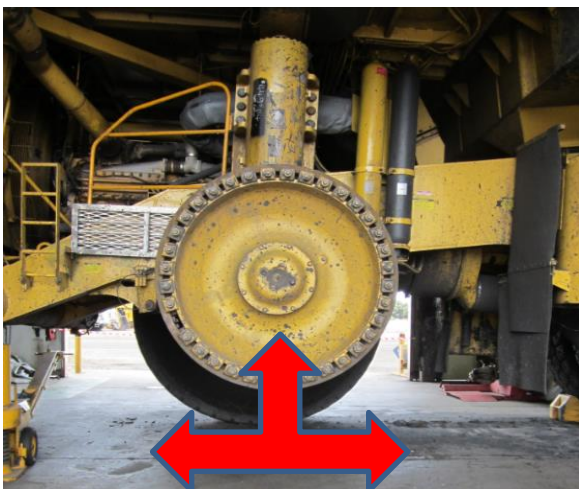
Recommendation 4

When working with loose componentry such as inner flanges, lock rings etc. NEVER put oneself in the 'line of fire' or 'crush zone' if they dislodge and are falling. As identified by the picture to the left
