Vehicle Dislodged from Jack & Stands

OHS & Compliance Officer
Safety Alert 89 130306 Vehicle Dislodged from Jack and Stands

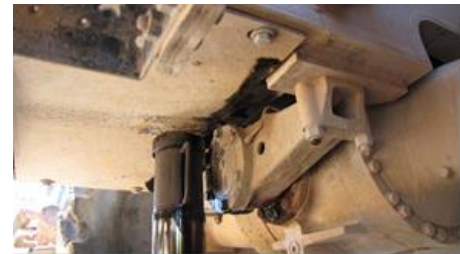
Whilst undertaking a tyre change on a CAT 950G Loader, the tyre service person, using a tyre handler, was removing position 4 when the loader dislodged from the jack and stand. This resulted in a bent belly plate and a small hole in the sump.

It was identified, during the course of the incident investigation that the tyre was a cross ply type and no tyre additive was present inside the tyre. These factors made it difficult to break the bead. The tyre service person used the bead breaker in four (4) different locations to ensure the bead was broken however the bead had not been entirely broken. Also, it was identified that the spotter's position did not allow him to identify the issue with the removal of the tyre and then the subsequent movement of the vehicle

1. Use correct tools and equipment for the job.
2. All tyres fitted shall have an approved bead lubricant applied and tyre additive added in correct quantities, to assist in tyre removal, in particular to break the bead.
3. All rims and rim componentry must be thoroughly cleaned prior to fitment.
4. When working on all vehicles, the spotter should be positioned in an area where they are visible to the tyre handler operator, and can identify any potential issues with the removal of the tyre or movement of the vehicle on the jack and stands.
5. Follow Tom's 5 "Nevers" – Number 3. Never rush a job. Always keep focussed on the task at hand to ensure that all work is completed safely.
